RIC (MIDLAND LAND) INC.

40 Wilson Avenue

Arborist Report and Tree Inventory and Preservation Plan

Arborist Report and Tree Preservation Plan – RIC (Midland Land) Inc. , 40 Wilson Avenue, in the City of Belleville, Hastings County, Ontario

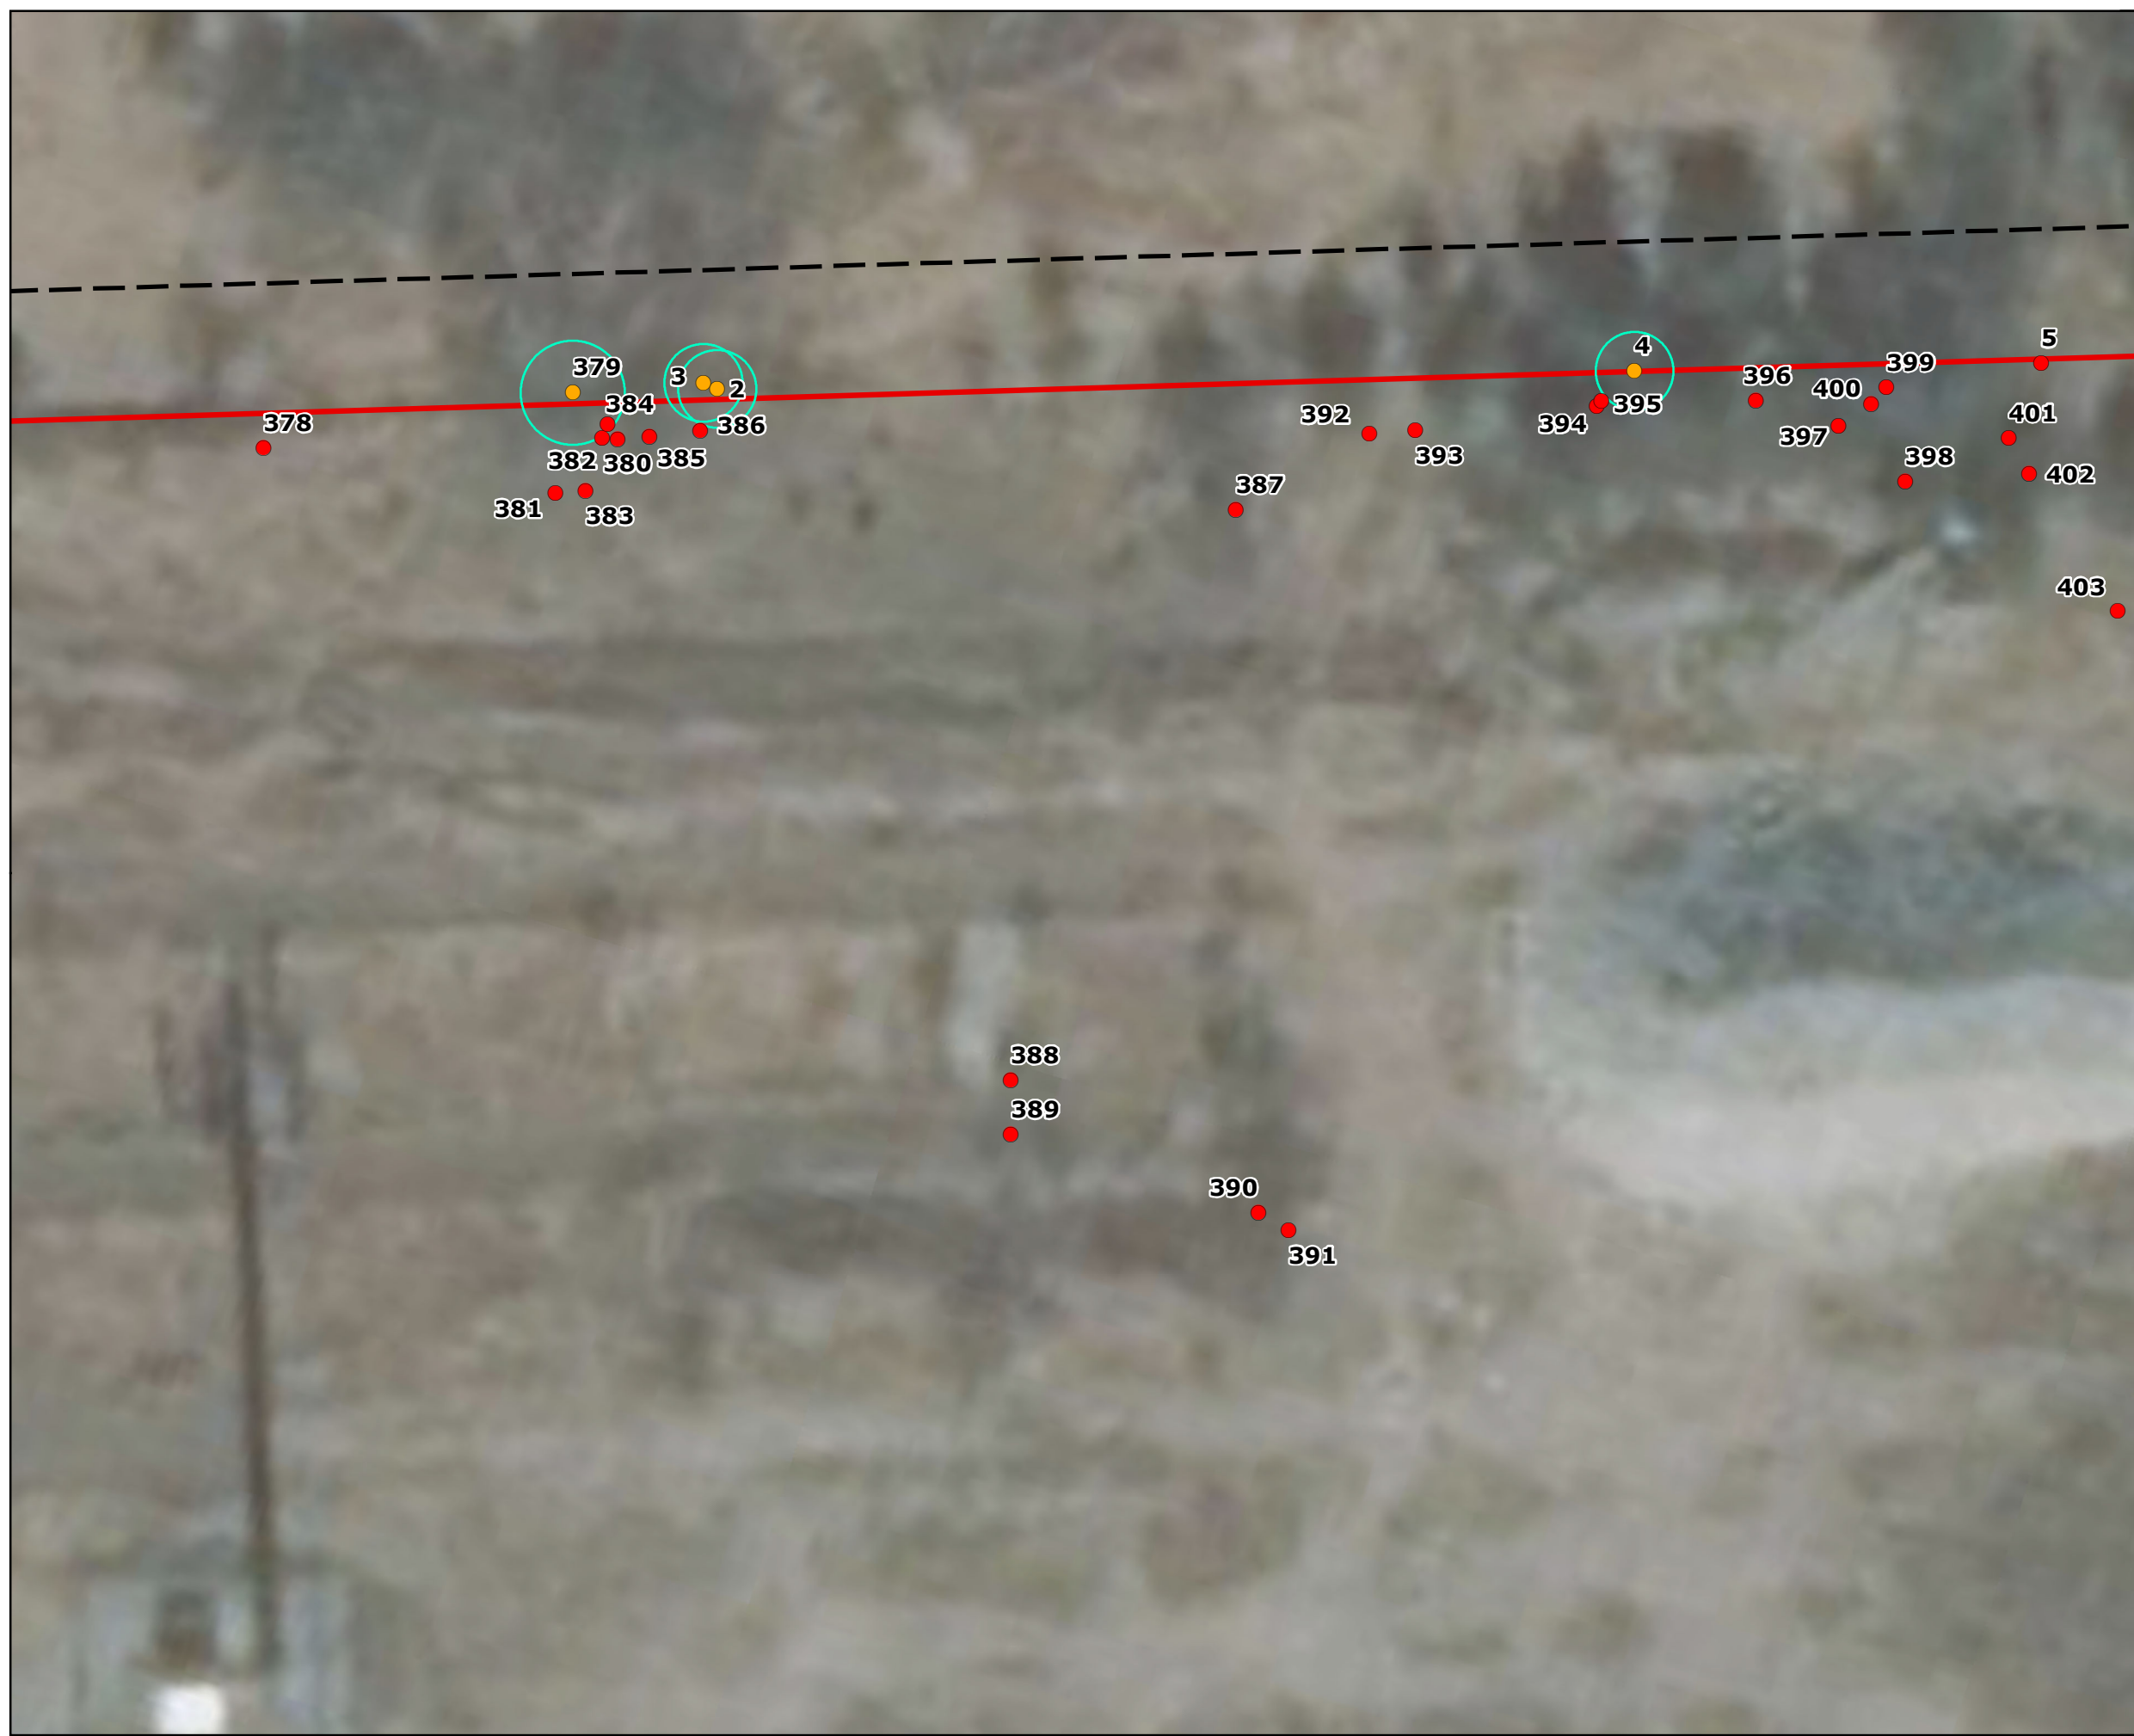
FIGURE 2B

Of the inventoried trees, 326 of the inventoried trees are recommended for removal as shown on the TIPP drawing (**Figure 2**), of which 317 are located entirely within the project footprint. Fourteen trees are located within the 6 m buffer, of which 9 have been identified for removal due to having 35% - 99% of their CRZ within the footprint.

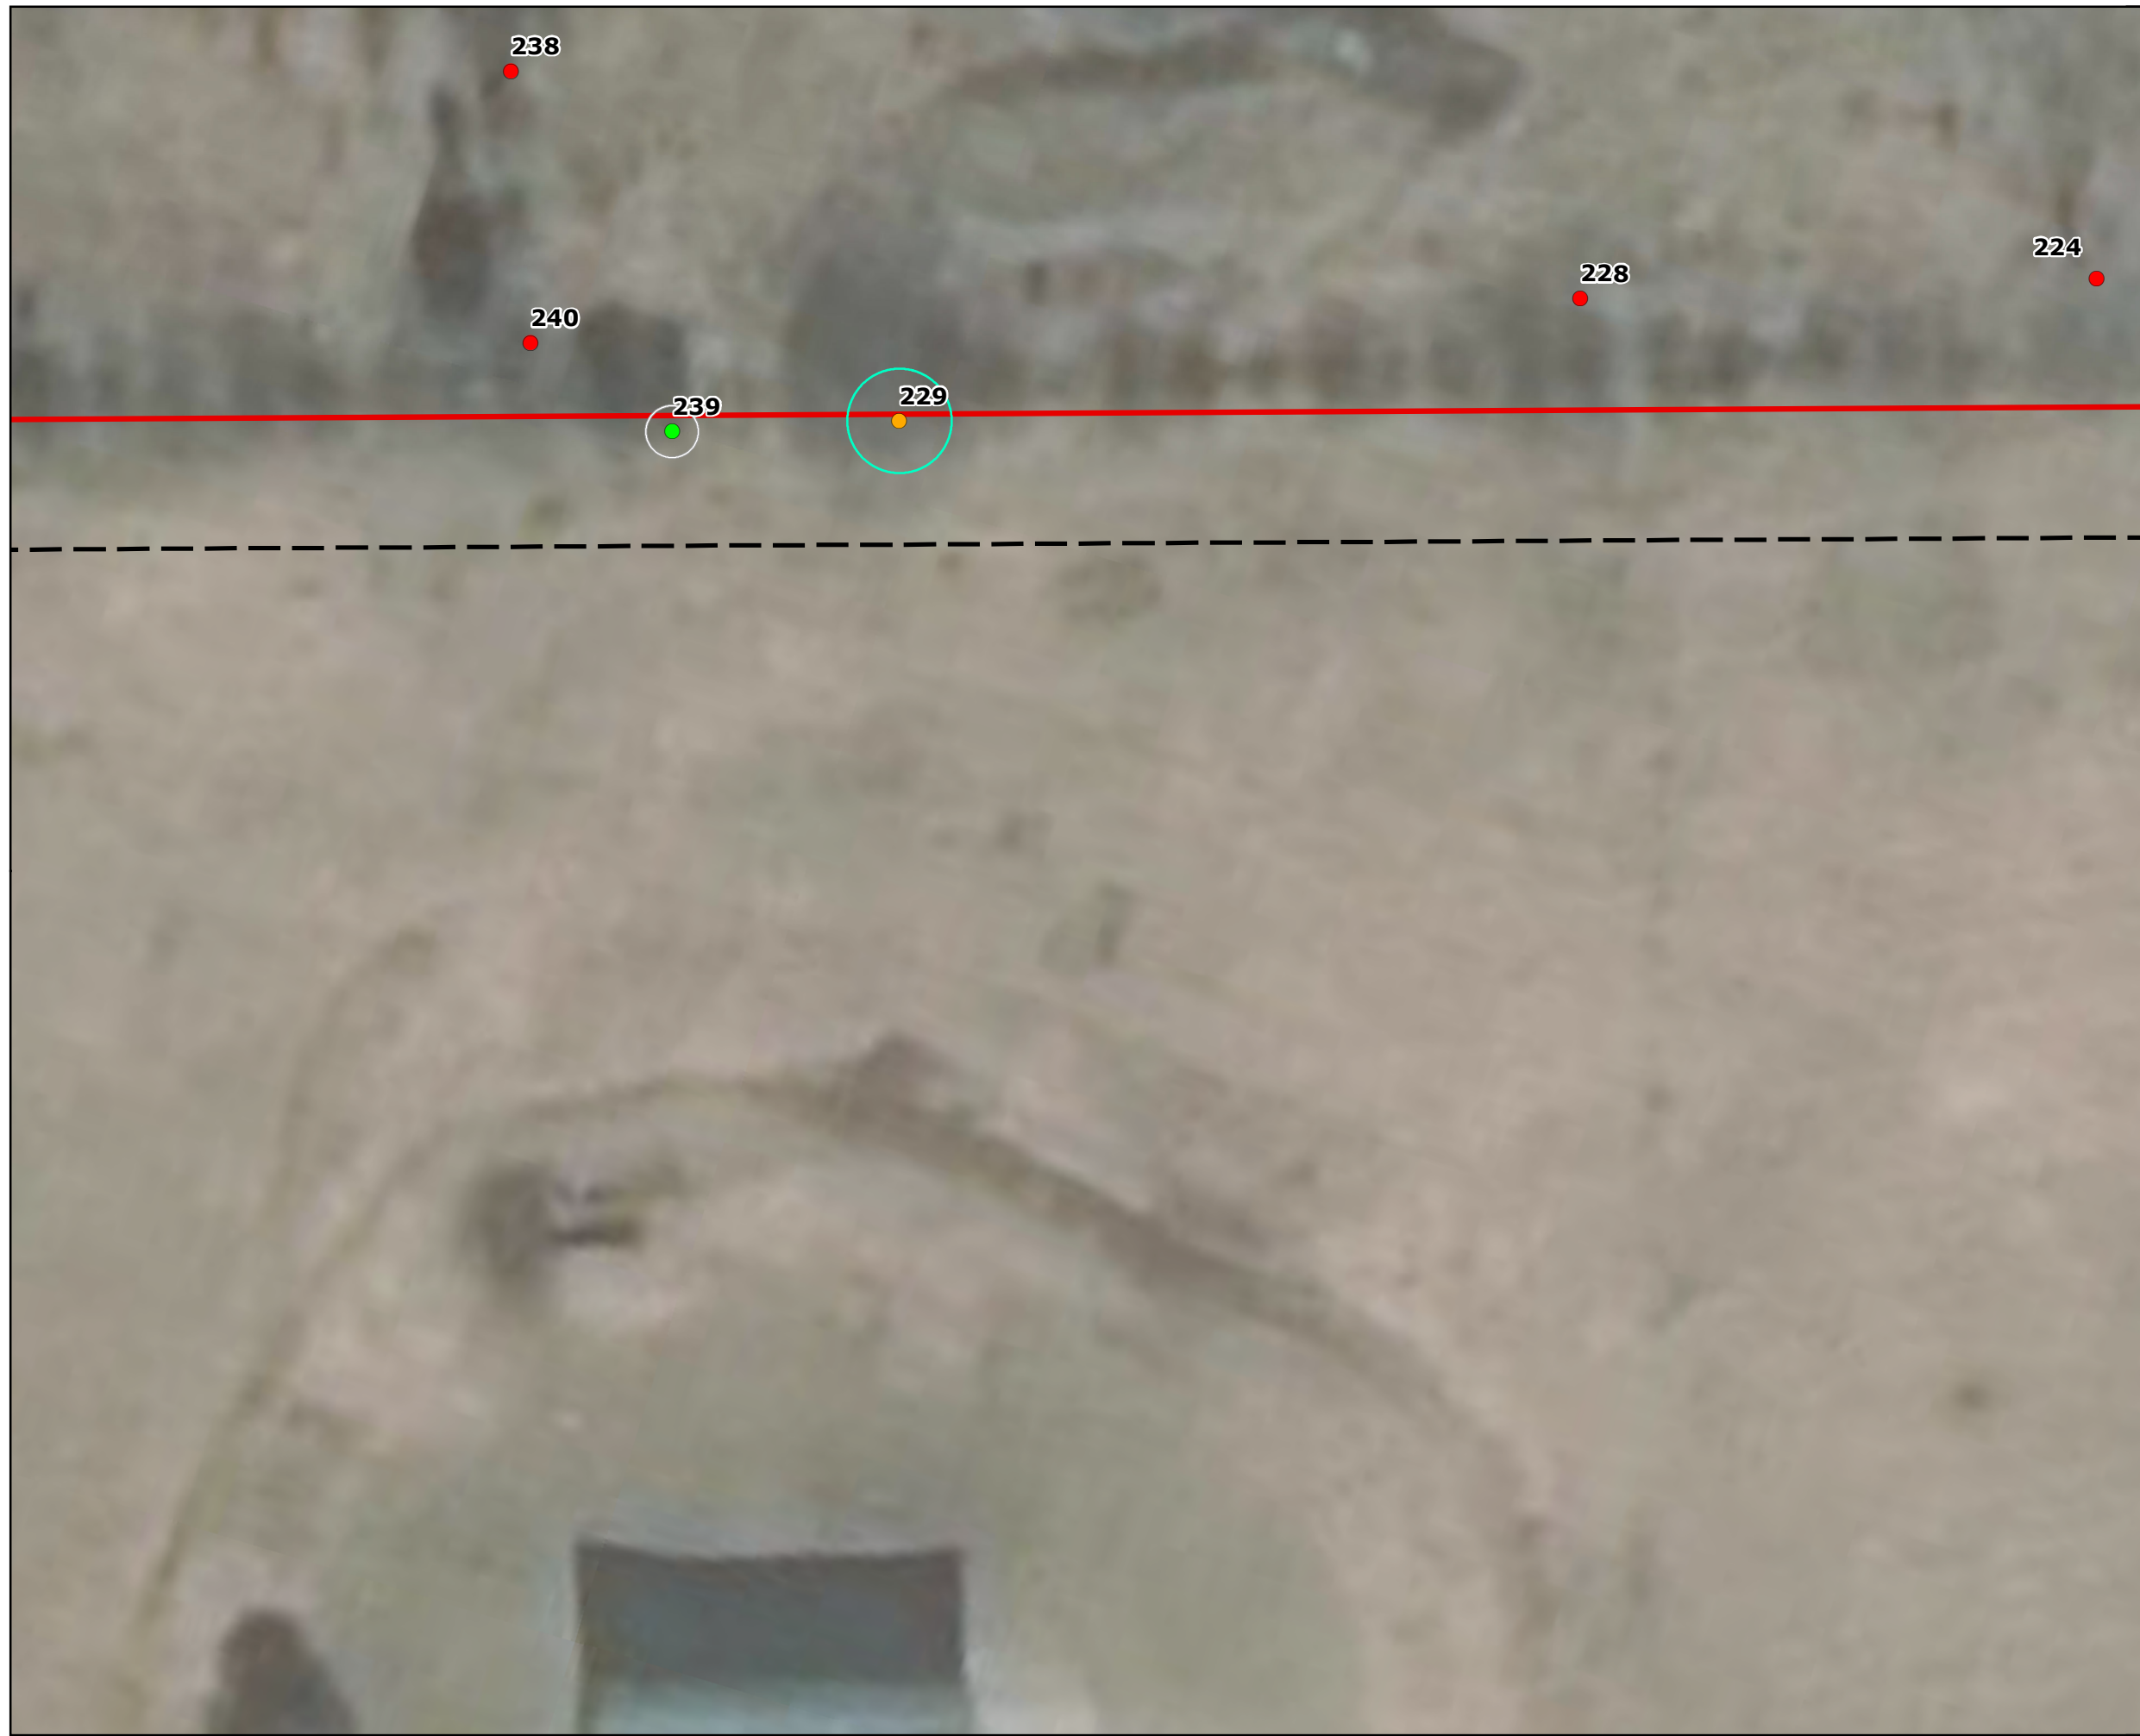
FIGURE 2N

The remaining five (5) inventoried trees are recommended to be retained. All 5 trees are located outside the project footprint (**Figure 2**) and are therefore not expected to sustain long-term impact from construction of the project, provided the mitigation measures outlined below are applied.

During excavation in close proximity to a CRZ of a protected tree, there is the potential that roots from the adjacent trees will be encountered and damaged. As such, when roots measuring 2.5 cm in diameter or larger are encountered, root pruning is recommended. This should be completed by an ISA Certified Arborist skilled in root pruning methods. During above-ground work adjacent to a CRZ, there is potential that branches from adjacent trees may obstruct construction access and/or be damaged. Such branches are recommended to be pruned in advance of construction in order to avoid improper damage. This should be completed by an ISA Certified Arborist skilled in branch pruning methods.
